Relation between toughness, infinite fatigue life and microstructure in large blooms for automotive plastic molds.

RELATION BETWEEN TOUGHNESS, INFINITE FATIGUE LIFE AND MICROSTRUCTURE IN LARGE BLOOMS FOR AUTOMOTIVE PLASTIC MOLDS.

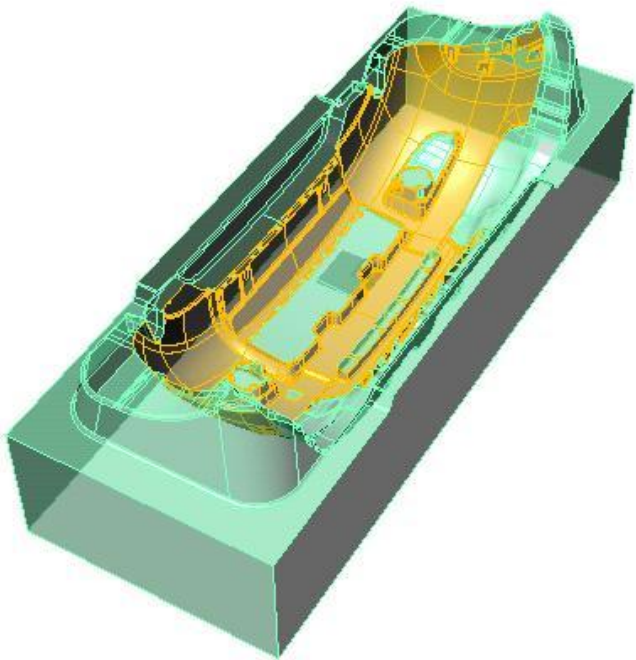
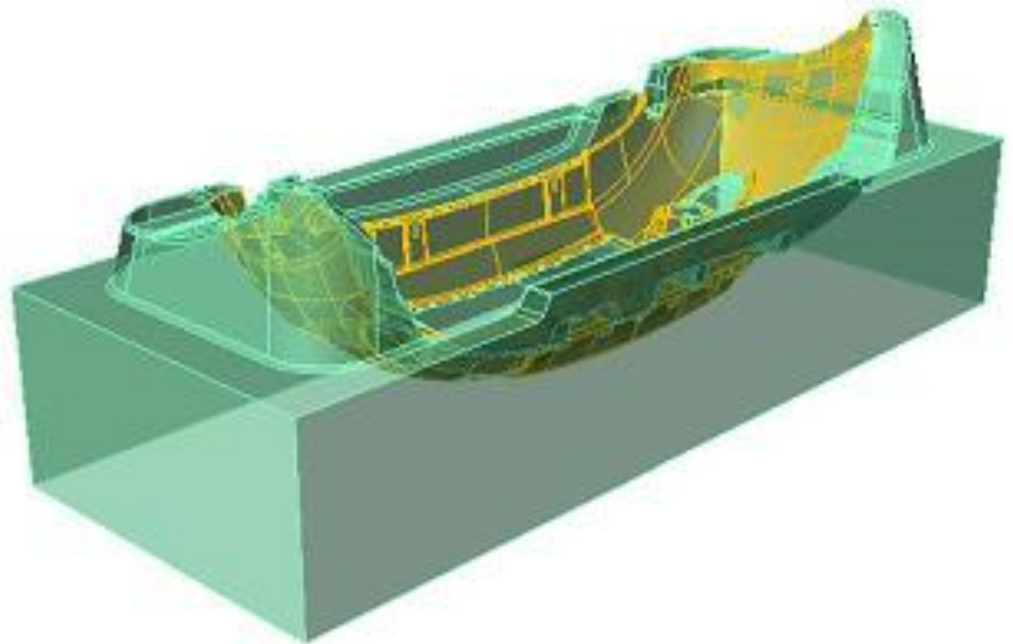
Overall views of a bumper mold.

Plastic molds machined from 1x1x3 m forged and pre-hardened steel blooms

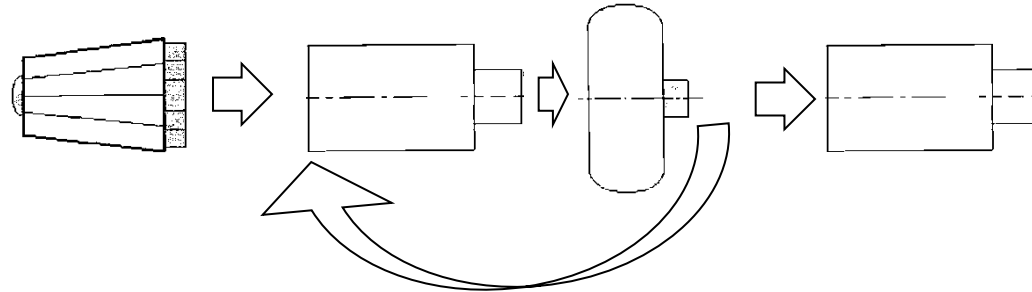
- comparable ingot and bloom section
- some repeated forging steps

- total reduction ratio much lower than in rolling (and not comparable)

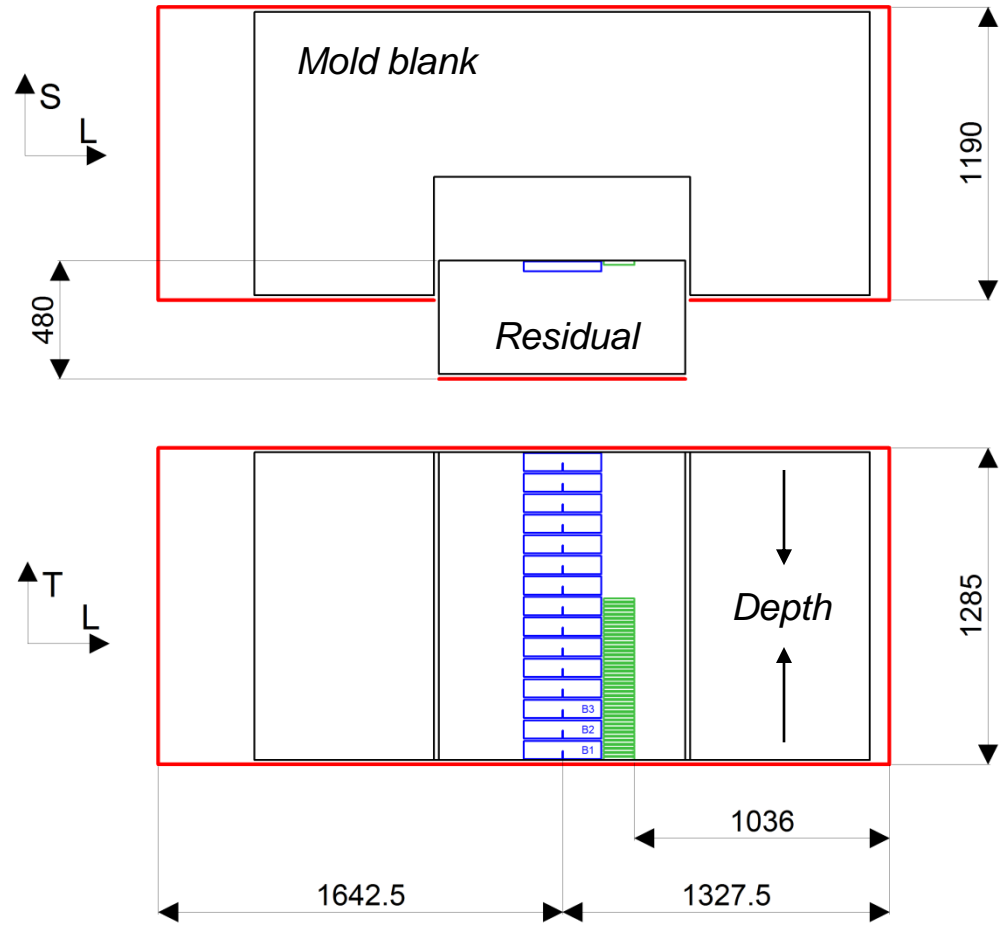
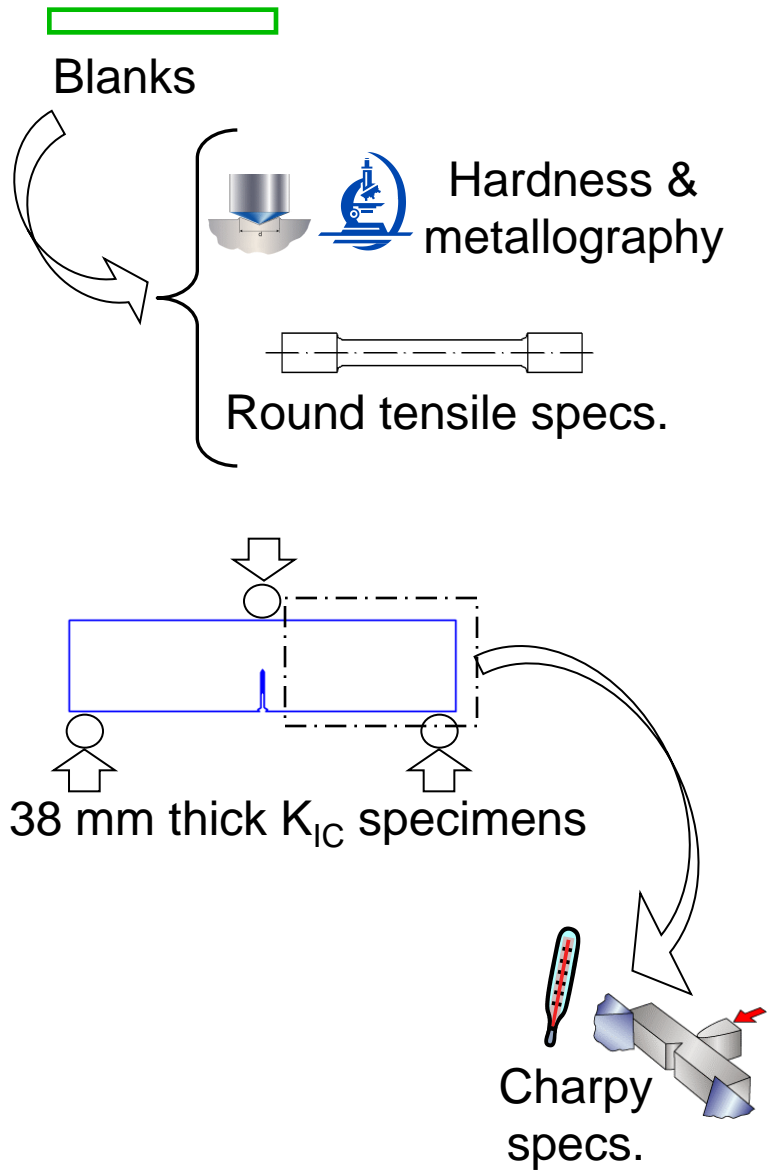
Sampling

Forged & heat-treated surfaces

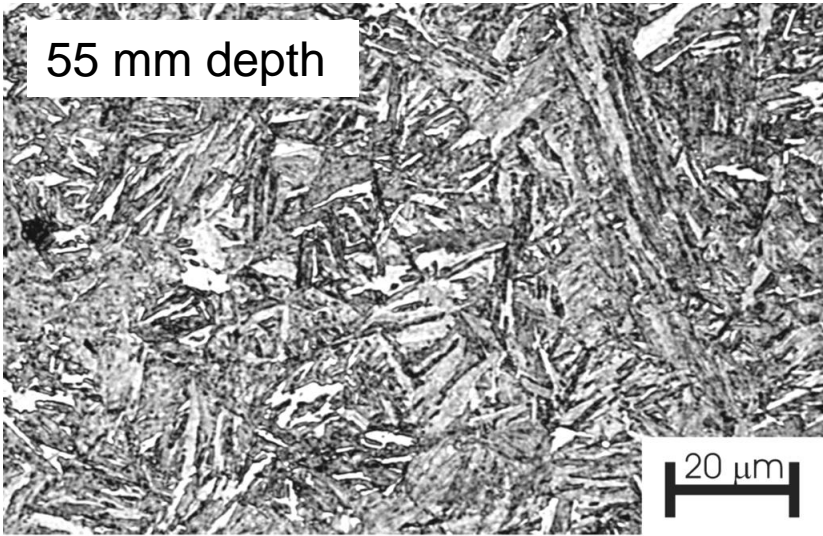
Metallography – microstructures vs. depth (Nital etch)

Tempered martensite, retained austenite transformed during tempering.

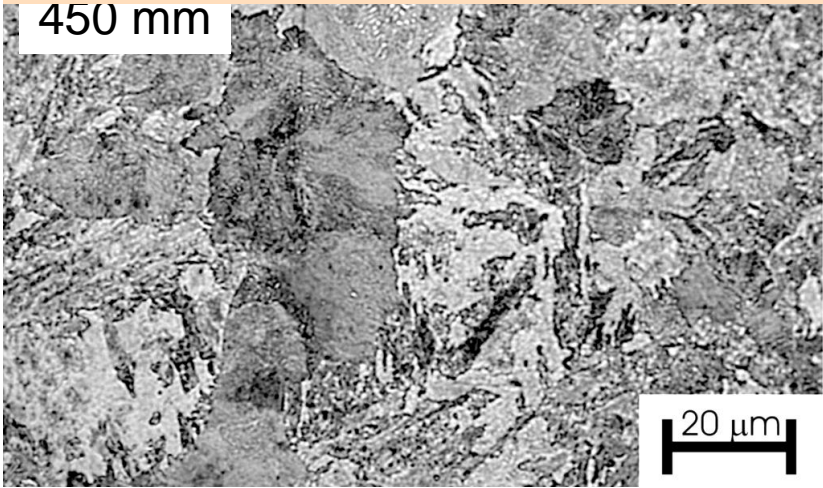
Fine and ultra-fine pearlite, upper bainite modified by tempering

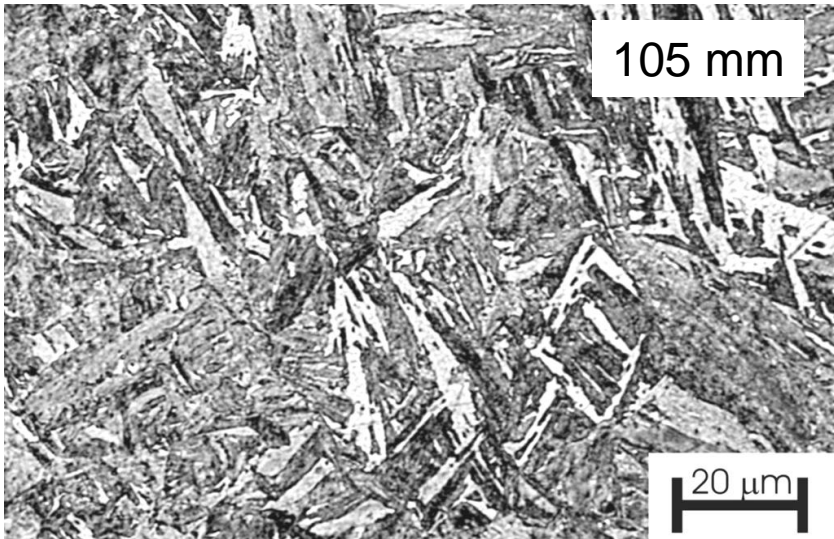
Lower bainite modified by tempering, retained austenite transformed during tempering

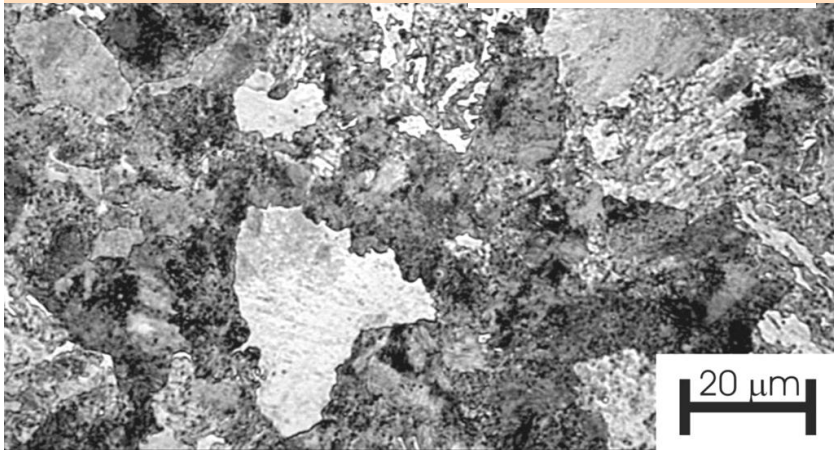
Fine pearlite, upper bainite modified by tempering

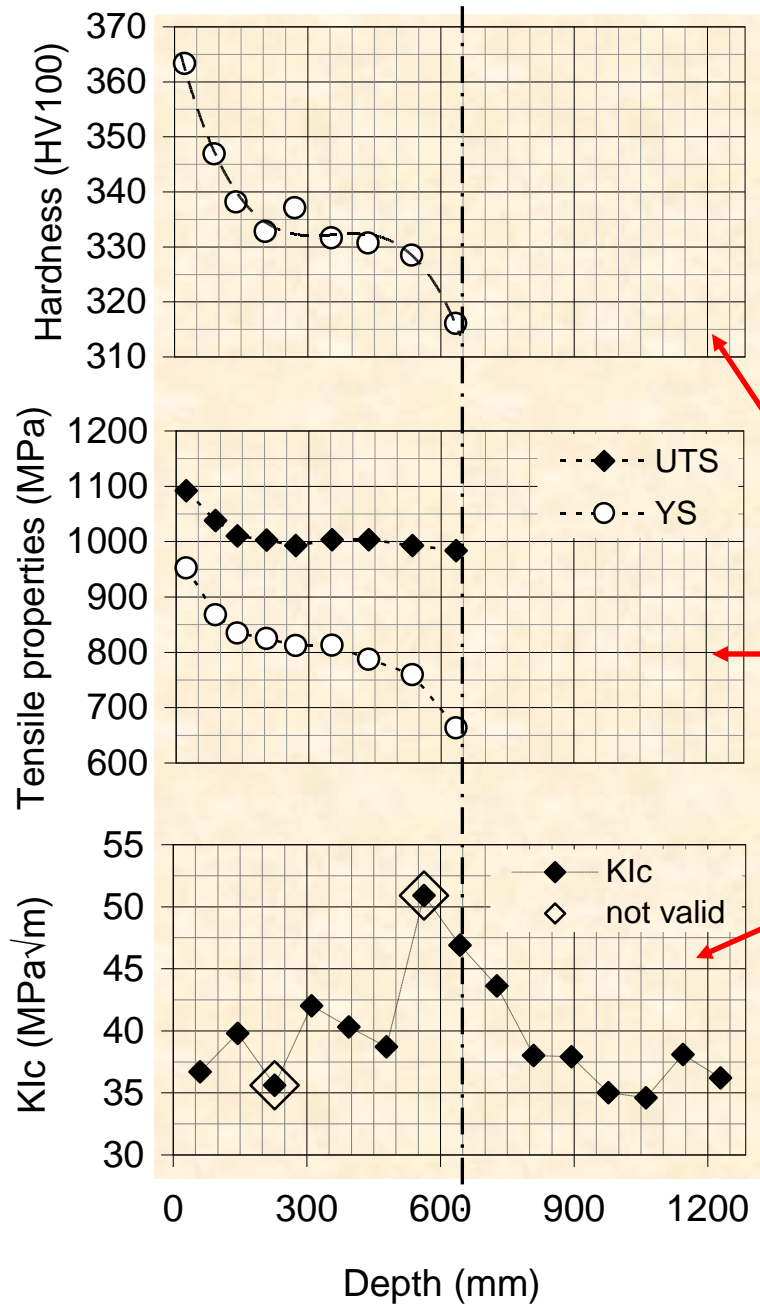
Mechanical properties: hardness, tension, fracture toughness

Charpy KV impact absorbed energy
50% FATT: Core 150°C - Surface 270°C

Hardness decreases from surface to core.

Tensile properties are adequate at the surface and decrease markedly at core (esp. YS).

Fracture toughness values are rather low.

The fracture toughness is exceptionally low for a Q&T steel. At the tested depths, K_{Ic} values were 38 MPa \sqrt{m} ca. close to the bloom surface and 43 MPa \sqrt{m} ca. near the core.

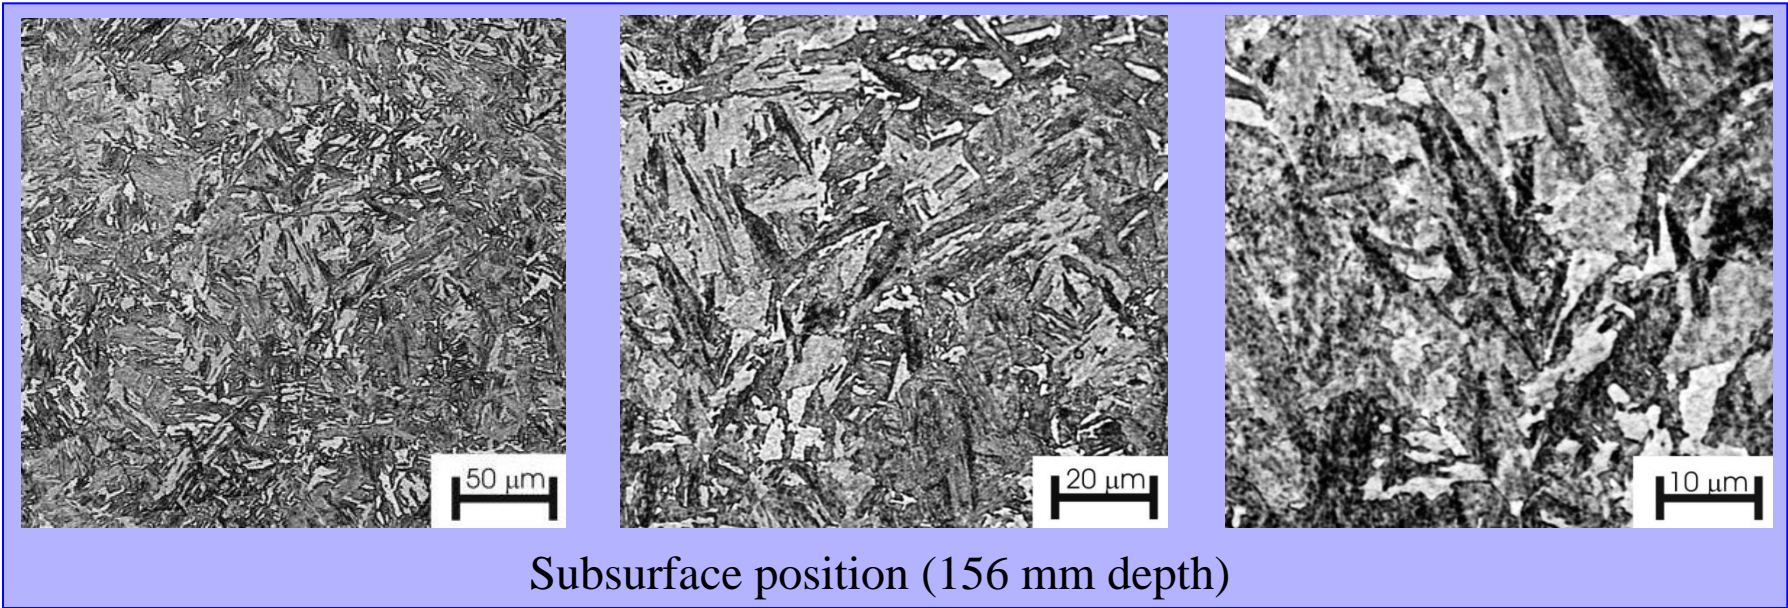
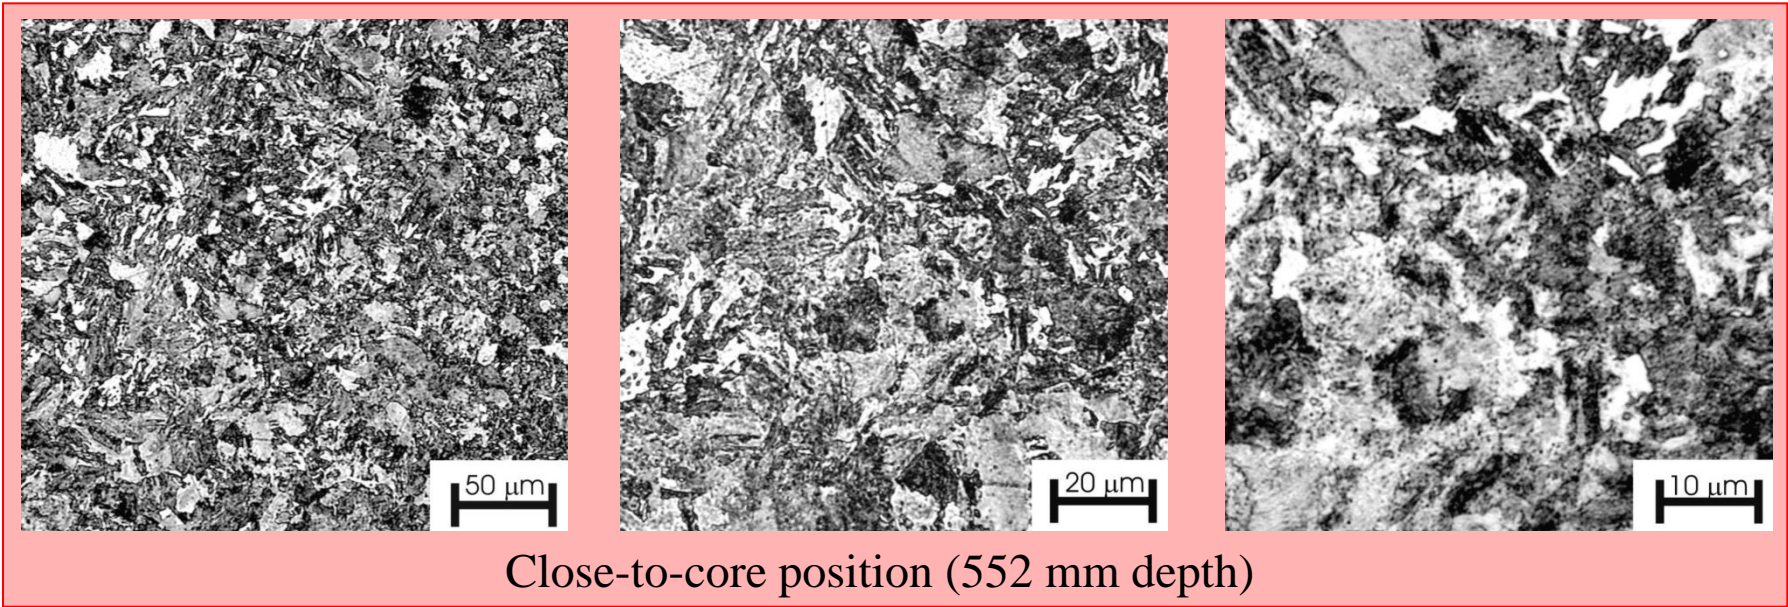
Metallography: microstructures at chosen positions (Nital etch)

Mixed microstructures occur throughout a pre-hardened steel bloom for dies apt to large plastic components fabrication.

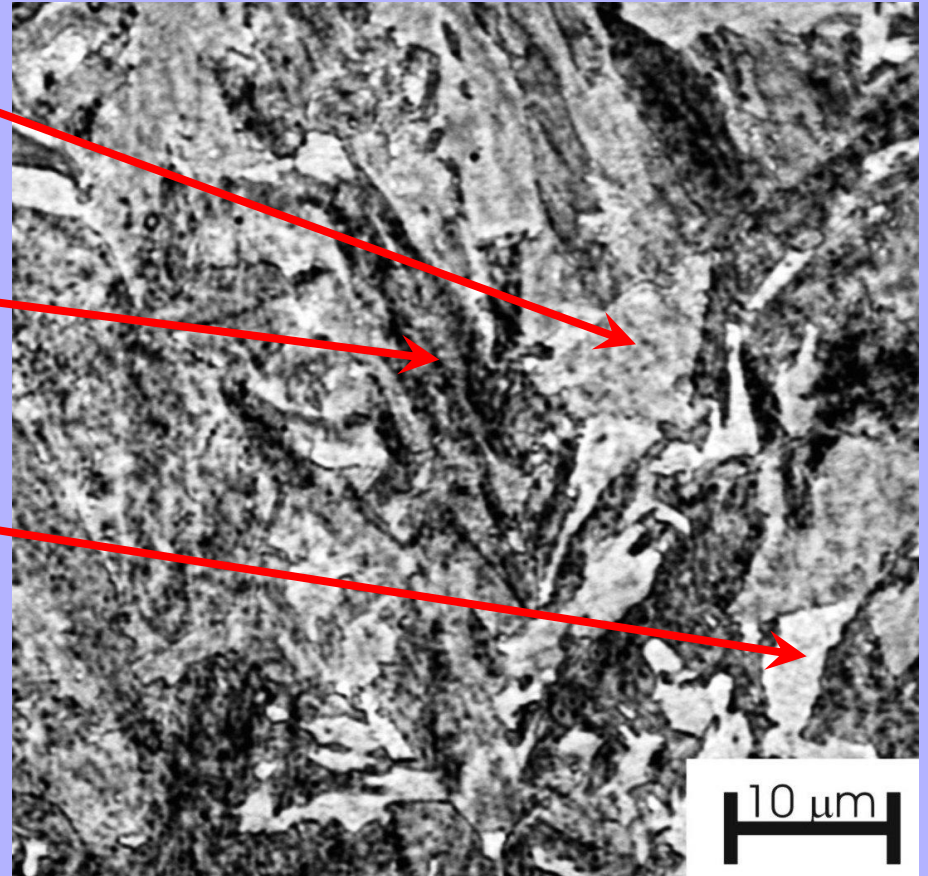
Metallography: subsurface microstructure – detail (Nital etch)

Tempered martensite

Lower bainite modified by tempering

Retained austenite with finely
scattered dark carbides due to its
transformation during tempering

Pearlite is completely absent.

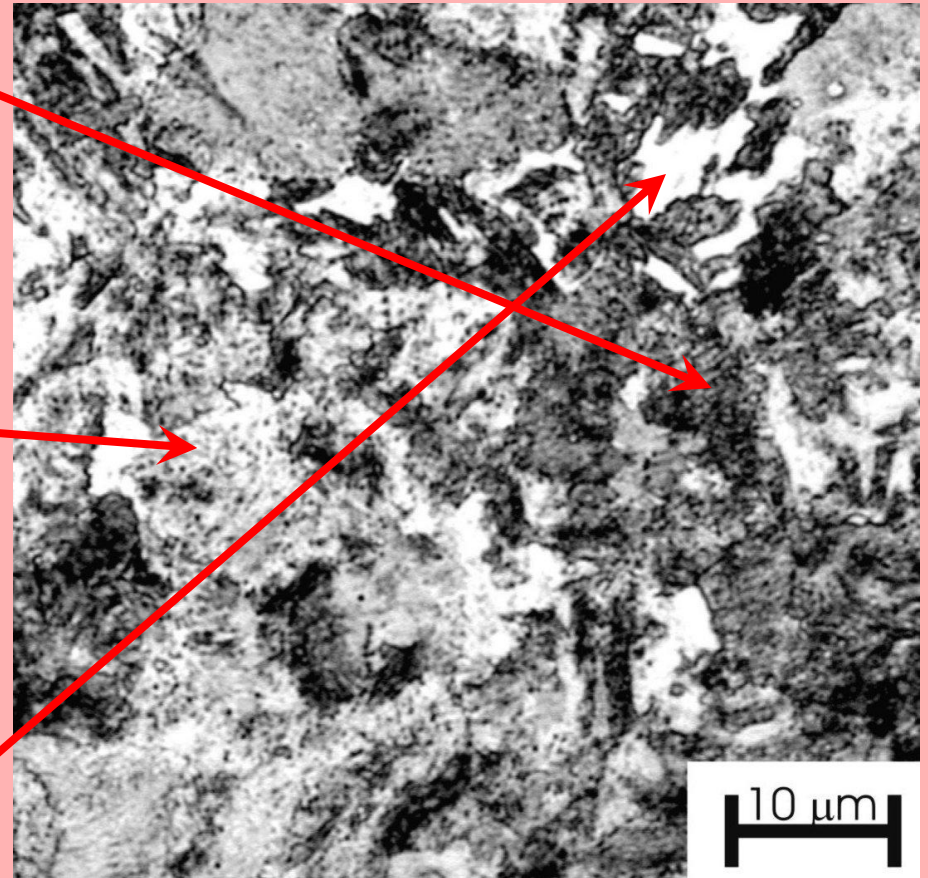
Metallography: close-to-core microstructure – detail (Nital etch)

Fine and ultra-fine pearlite

Upper bainite, modified and
subjected to carbide coarsening
during the tempering stages

(lightly attached upper bainite)

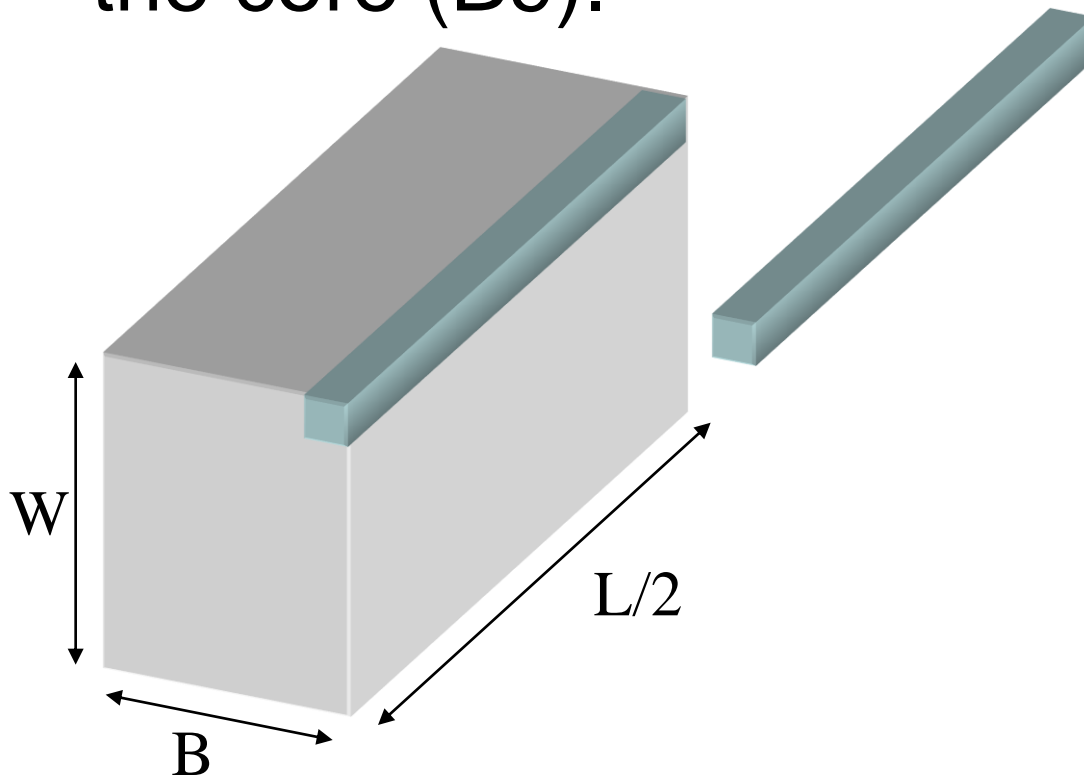
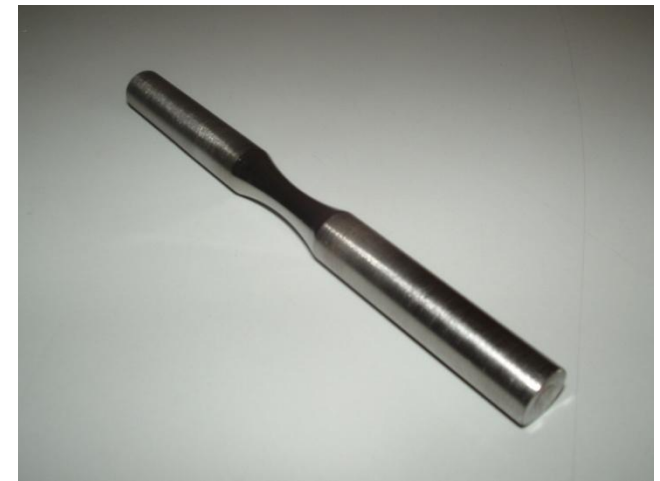
Rotating Bending Fatigue

- All samples have been machined from the two halves of two broken K_{Ic} samples, one near the surface (B14) and the other next to the core (B9).

$D_{\min (nom)} = 6 \text{ mm}$

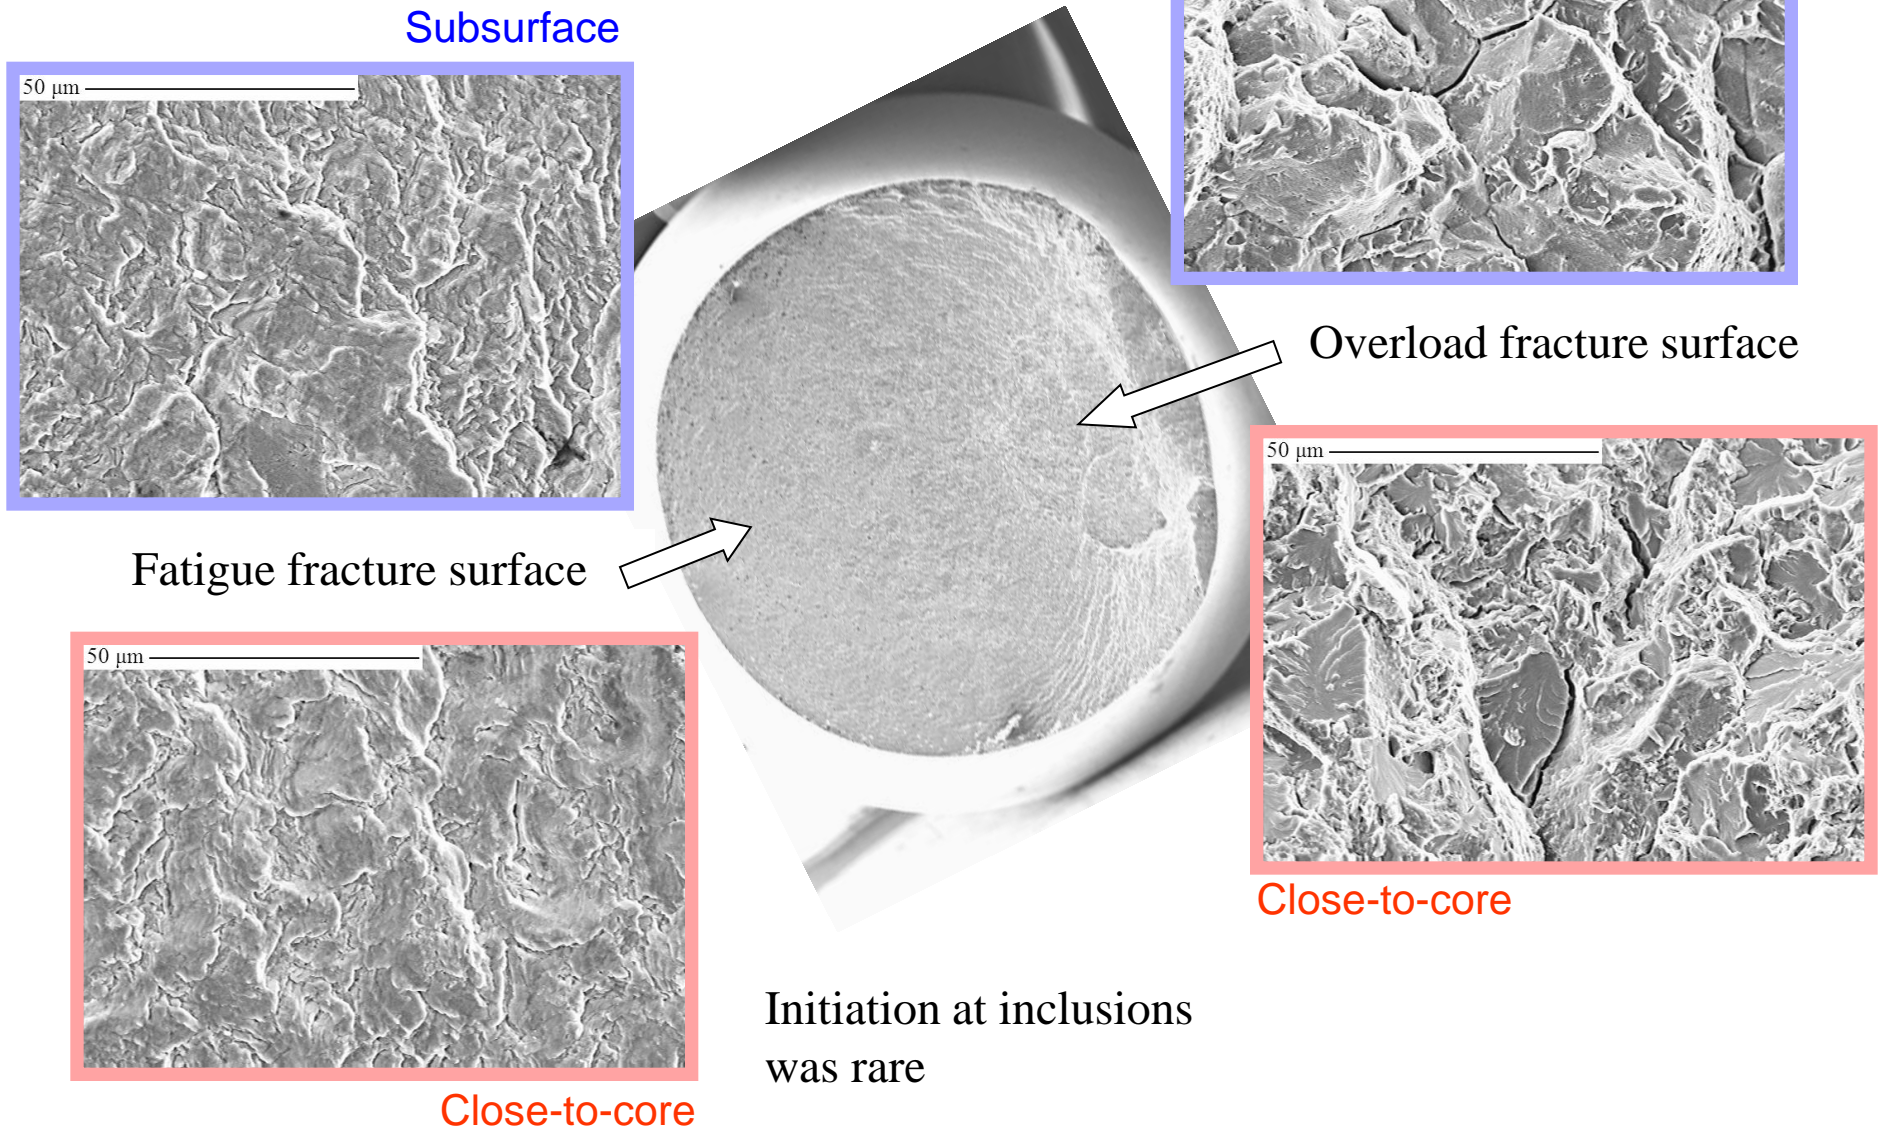
Fractography (As-received specs.)

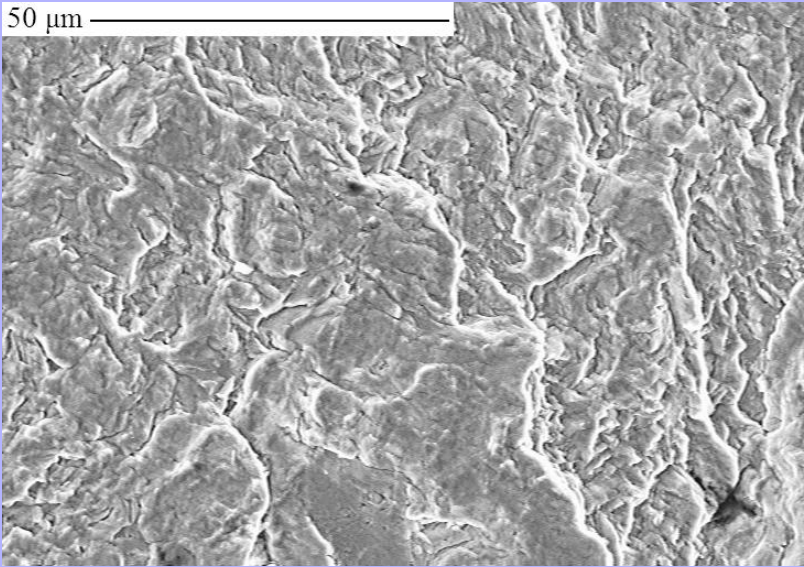
Subsurface

Fractography: fatigue areas

As-received

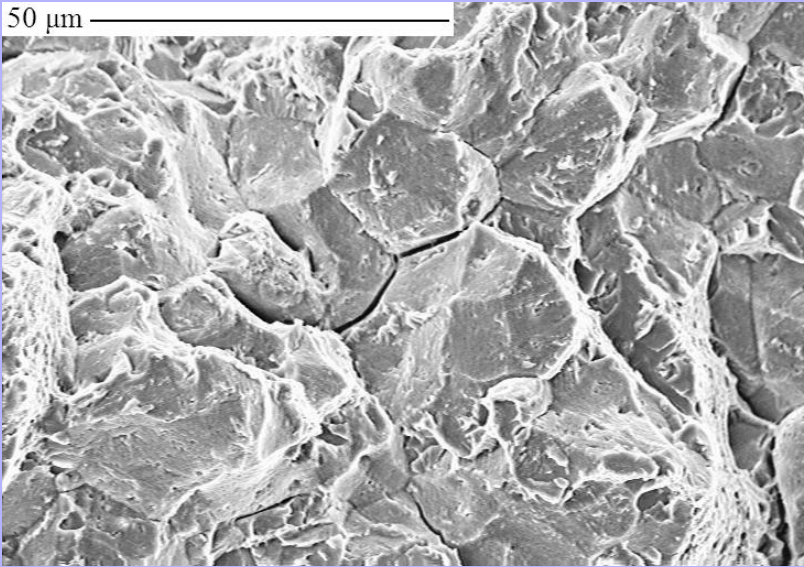
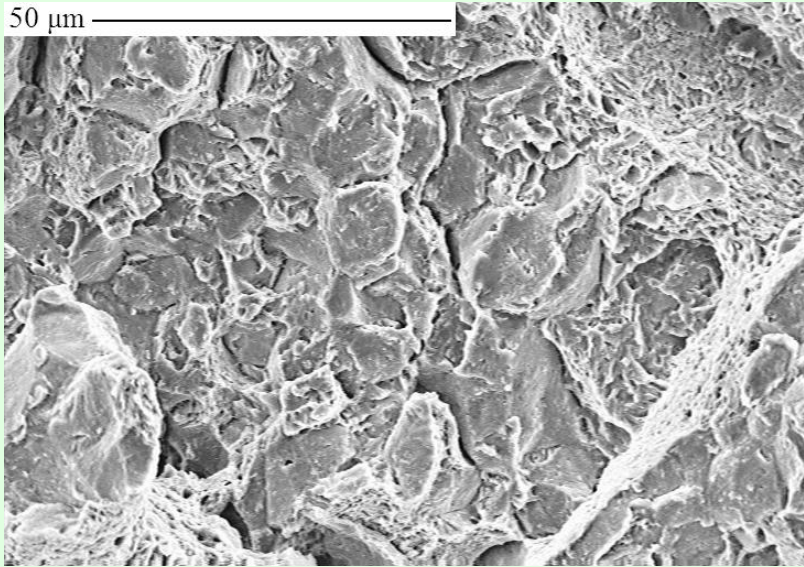
Subsurface

Fractography: overload areas

As-received

Re-heat-treated
